太陽光電系統失效問題檢測

PV Guider
首席顧問 林敬傑

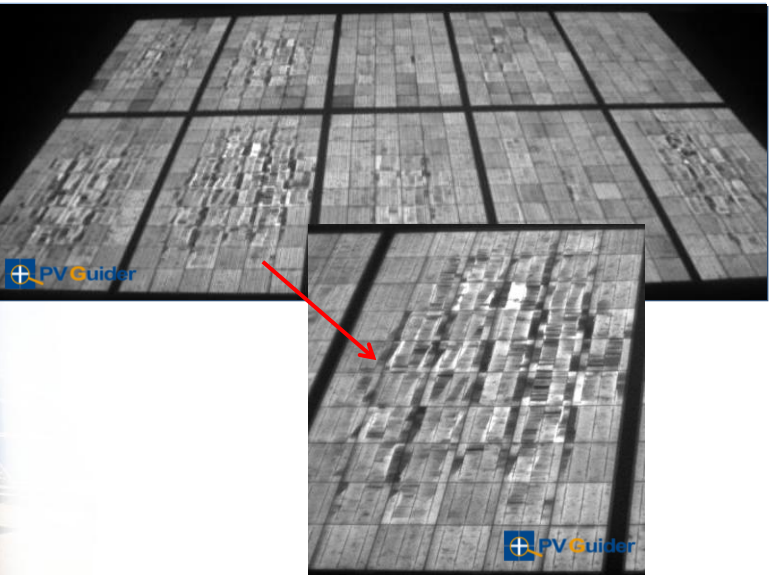
安裝、維護不當 (踩踏破片、搬運碰撞)

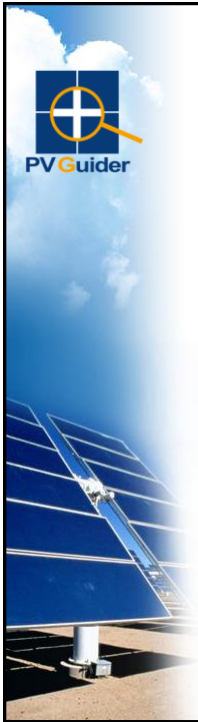
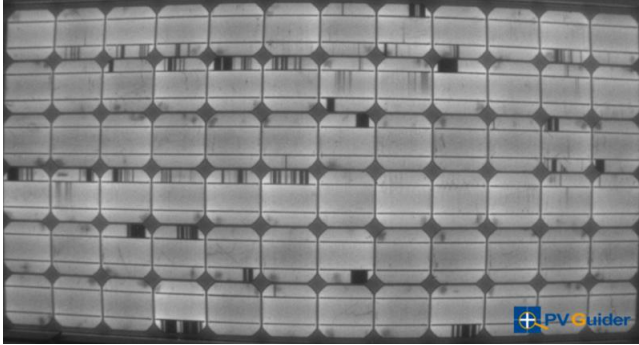
模組來料不良

過焊暗區隨時間擴大
對功率影響越來越大

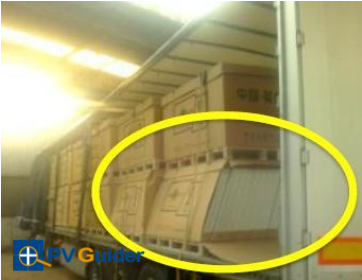
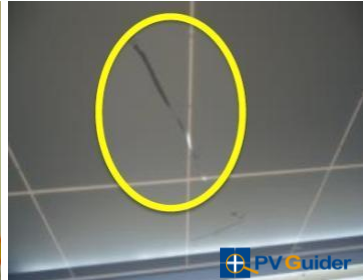
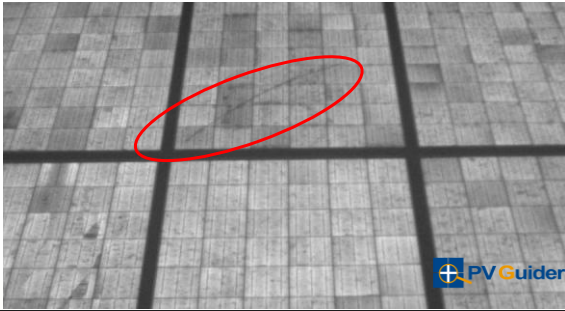
模組刮傷、運輸損傷

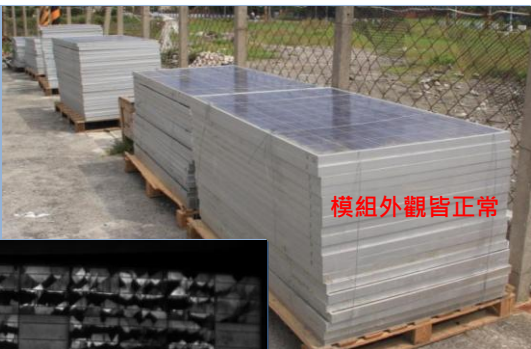
颱風吹落的模組

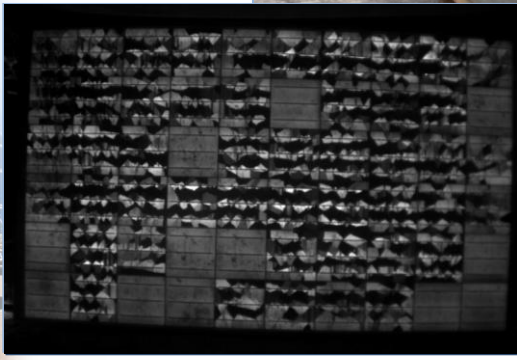
模組外觀皆正常

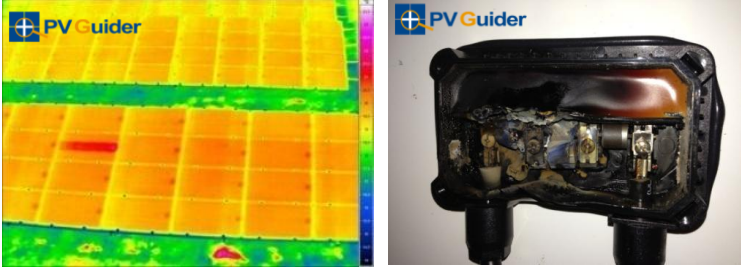
IR可辨識缺陷-電路缺陷

旁路二極體短路不容易從監控系統發現
 二極體過熱會燒毀接線盒，甚至引起火災
 熱影像檢測可以輕易找出缺陷模組

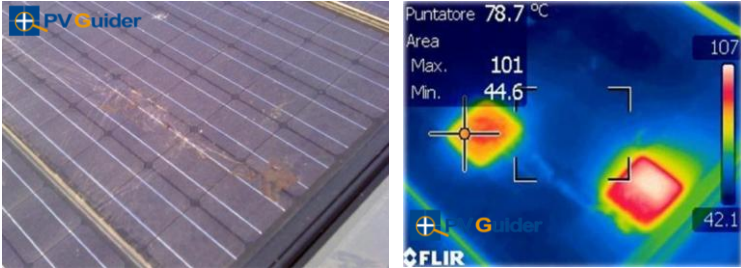
IR可辨識缺陷-積垢

鳥糞、落葉等局部遮陰也會造成高溫熱斑
 長期沒有處理會造成EVA黃化、背板脆裂等問題
 會使發電效率降低，進水漏電等問題

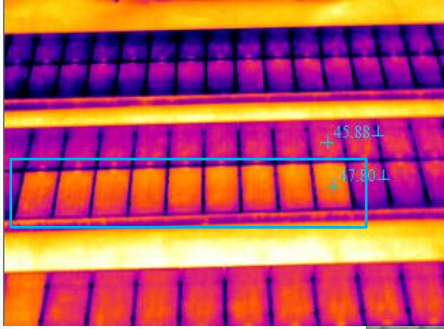
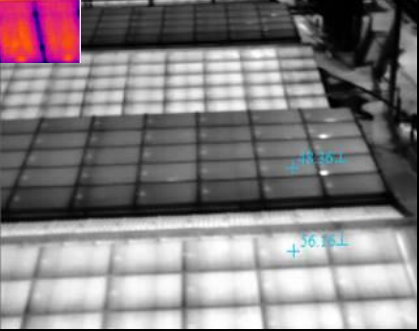
45.88°C
67.83°C

平貼屋頂與北面架高溫差8度

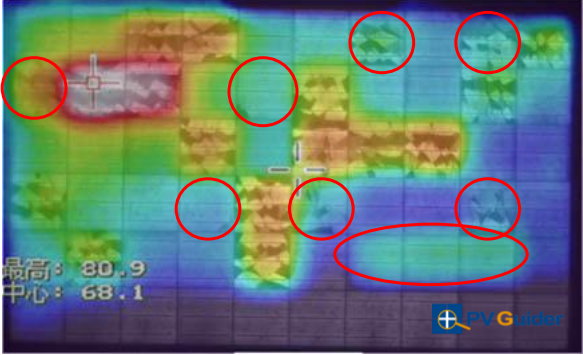
IR與EL疊圖

最高: 80.9
中心: 68.1

- 電池片破裂程度嚴重才会有高溫
- 溫度高的電池未必有隱裂
- 了解高溫原因需要其他分析工具，如EL檢測
