電池與模組新技術的新問題-IEA Task 13新年度專題

林敬傑/ 首席顧問
PV Guider

電池與模組新技術的新問題

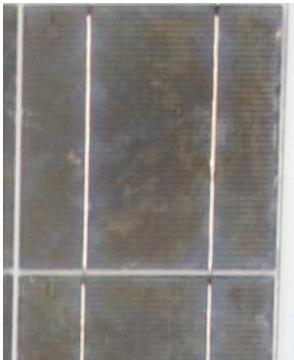
85°C/85%RH/+600V/2000 h
結果顯示SiN層退化

PID type	PID corrosion
Cell types	Various
Mechanism	對cell的負偏壓：矽的陰極反應，產生NH ₃ 和hydrous silica
Sensitivities	高濕度、高系統電壓
Mitigation	研究不多，但是預期阻抗更大的封裝材有幫助

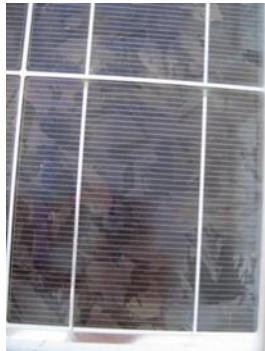
4年戶外1500V系統有類似症狀
